# GEOTECHNICAL ENGINEERING REPORT

Port Gamble S'Klallam Tribe Little Boston  
Road Project

Prepared for: Otak, Inc

Project No. 220389-A-005 • APRIL 3, 2024 FINAL

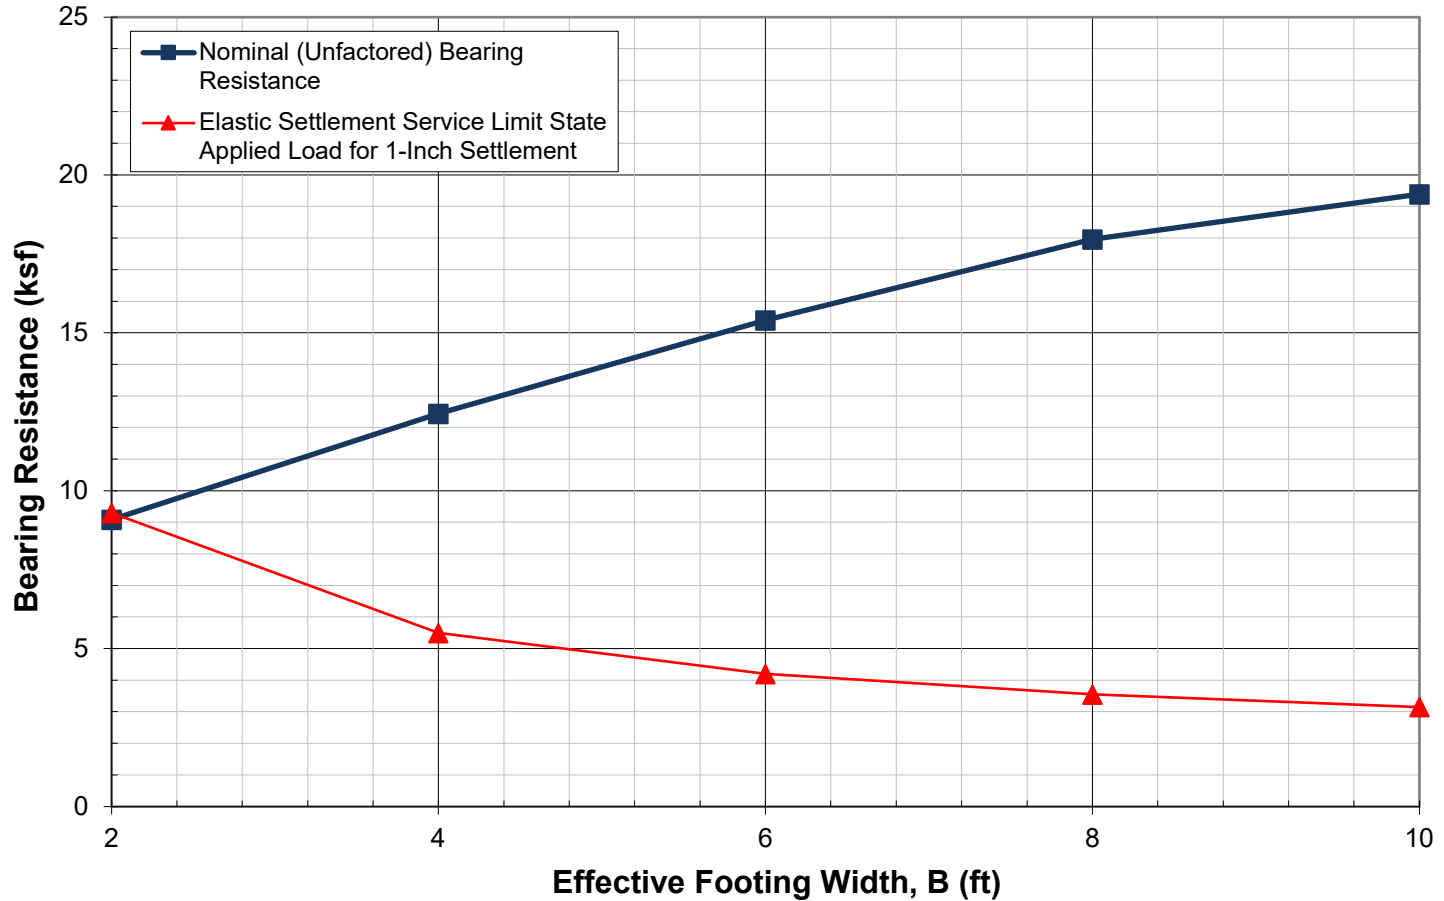
## Bearing Resistance For Shallow Rectangle Footings

1. Assumes shallow strip foundations on medium dense to dense recessional outwash deposits.
2. Recommended resistance factors of 0.45 and 1.0 for Strength Limit State and Extreme Event Limit State, respectively.
3. Assumes a rectangular footing that is 14 feet long and with varying widths.

We understand that the two smaller bridges, Bridge 1 and Bridge 2, will be 45 feet and 55 feet end-to-end prefabricated steel trusses, respectively. We recommend that the proposed smaller bridges bear on rectangular strip footings. These footings should be constructed on a crushed rock leveling/bearing pad overlying the recessional outwash. This will require that sub-excavation of existing fine-grained recessional lacustrine clay to expose the underlying recessional sand and gravel. Recommended bearing capacities based on allowable settlement and the width of the footing are presented on Figure 3.
